Bluegrass Condominiums

Tree Inventory and Conditions

April 20, 2015

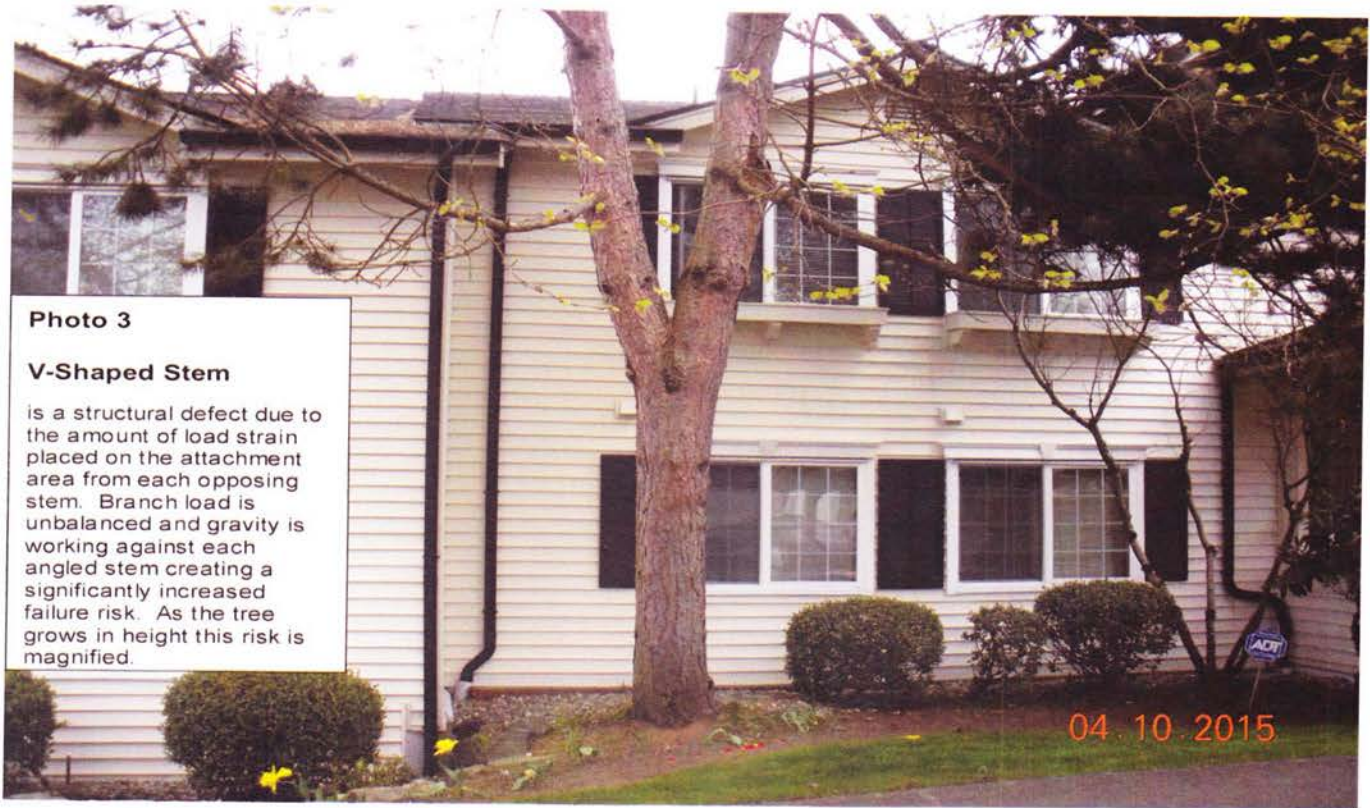
Photo 3

V-Shaped Stem

is a structural defect due to the amount of load strain placed on the attachment area from each opposing stem. Branch load is unbalanced and gravity is working against each angled stem creating a significantly increased failure risk. As the tree grows in height this risk is magnified.

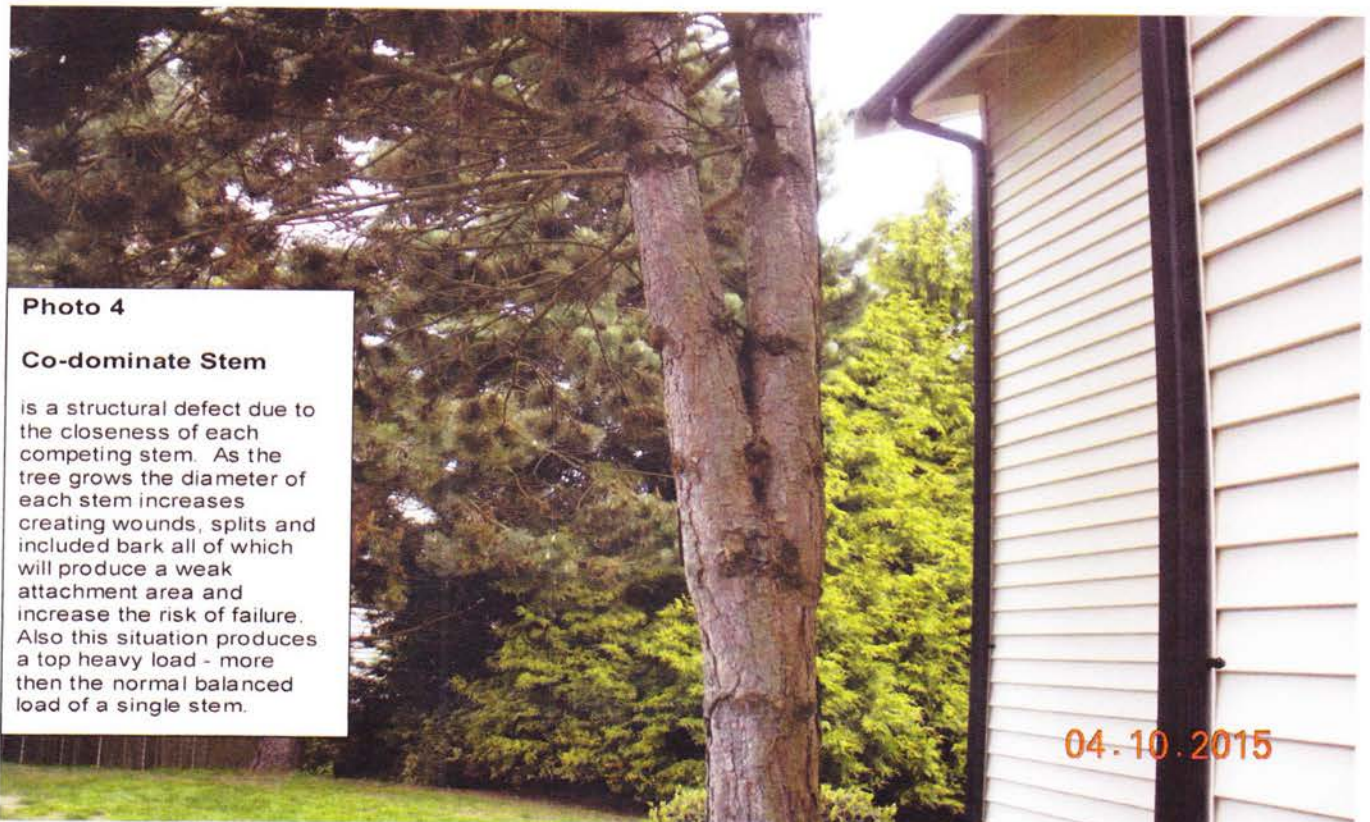
Photo 4

Co-dominant Stem

is a structural defect due to the closeness of each competing stem. As the tree grows the diameter of each stem increases creating wounds, splits and included bark all of which will produce a weak attachment area and increase the risk of failure. Also this situation produces a top heavy load - more than the normal balanced load of a single stem.
